**Flood Control Project Maintenance
Levee Inspections**
LMA District Cover Sheet
Spring 2017 Levee Inspection Results

American River Flood Control District

Spring 2017 Levee Inspection Results

Waterway			Bank	Unit Miles
Unit No. 01 Arcade Creek			Left	2.08
	Spring (March - May)	Summer (June - August)	(September - November) Fall	Winter (December - February)
Unit Maintenance Rating (Fall Only)				
Date of Inspection	3/15/2017 - 5/3/2017			
DWR Inspector	Maksim Khashchuk			
Accompanied By	Ross Kawamura ARFCD

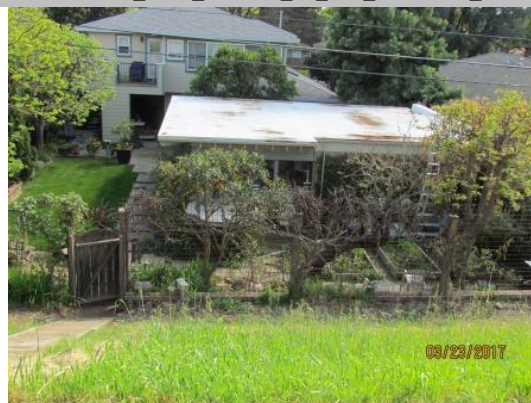
Photo 1 of 1 : SP_2017_NA0001_55_207_20170406_00273.jpg

LM Start	4.90	Rating **	M	Issue No.	207
LM End	4.90	Issue Type +	En	Location *	LS
Category	Earthen Levee			GPS Latitude/Longitude	
				Start	End
Item	Encroachments			38.580806 °	38.580806 °
				-121.431266 °	-121.431266 °
DWR ID	DWR_NA0001_04_s _ 2012_207				
Comment Code					
FE : Fence					
Inspector Comment					
Fence at levee toe.

View of the fence at the levee toe.

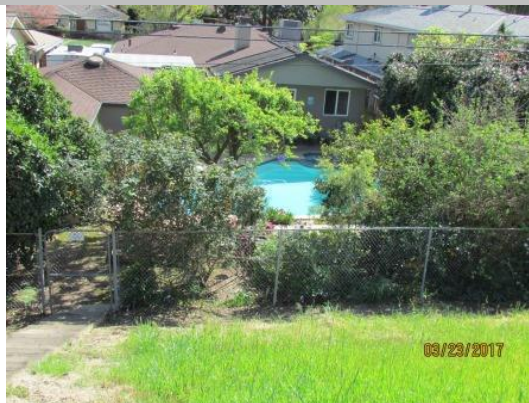
Photo 1 of 1 : SP_2017_NA0001_55_264_20170406_00272.jpg

LM Start	4.91	Rating **	M	Issue No.	264
LM End	4.91	Issue Type +	En	Location *	LS
Category	Earthen Levee			GPS Latitude/Longitude	
				Start	End
Item	Encroachments			38.580820 °	38.580820 °
				-121.431045 °	-121.431045 °
DWR ID	DWR_NA0001_04_s_2017_264				
Comment Code					
FE : Fence					
Inspector Comment					
Chain-link fence at levee toe.

View of the fence at the levee toe.

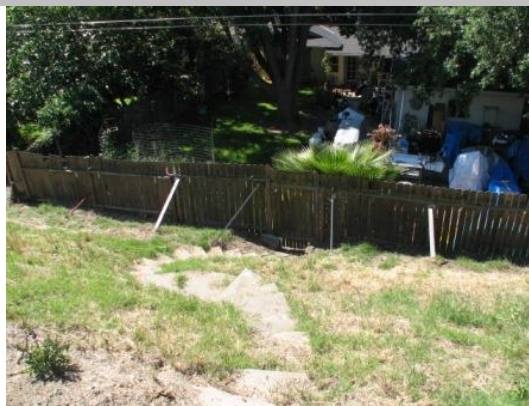
Photo 1 of 1 : SP_2017_NA0001_55_45_20170313_00036.jpg

LM Start	4.93	Rating **	U	Issue No.	45
LM End	4.93	Issue Type +	En	Location *	LS
Category	Earthen Levee			GPS Latitude/Longitude	
				Start	End
Item	Encroachments			38.580844 °	38.580844 °
				-121.430672 °	-121.430672 °
DWR ID	DWR_NA0001_04_s_2012_45				
Comment Code					
FE : Fence					
Inspector Comment					
Wooden fence with bracing obstructs access and visibility.

Wooden fence and braces obstruct access and visibility.

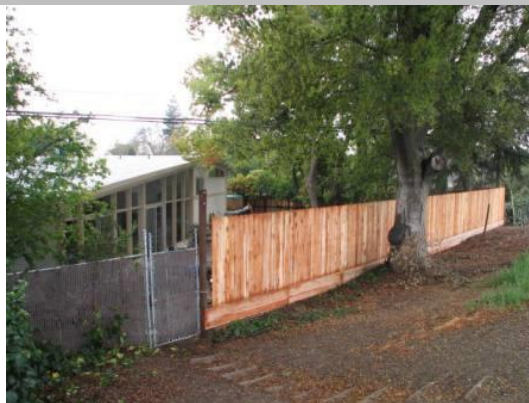
Photo 1 of 1 : SP_2017_NA0001_55_208_20170313_00171.jpg

LM Start	5.13	Rating **	U	Issue No.	208
LM End	5.13	Issue Type +	En	Location *	LS
Category	Earthen Levee			GPS Latitude/Longitude	
				Start	End
Item	Encroachments			38.580882 °	38.580882 °
				-121.427038 °	-121.427038 °
DWR ID	DWR_NA0001_04_s_2012_208				
Comment Code					
FE : Fence					
Inspector Comment					
Privacy fence and landscaping within 10-ft of the levee toe obstruct access and visibility.

03/16/2012 Wood privacy fence completely obstructs access and visibility.

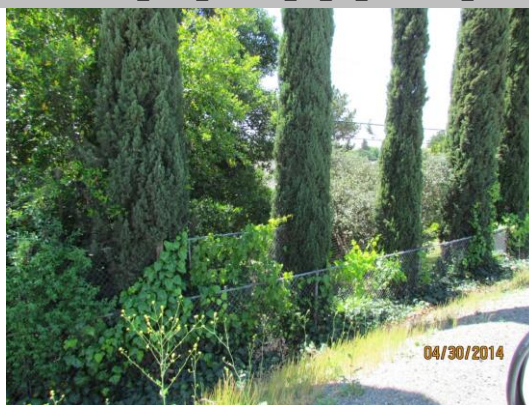
Photo 1 of 1 : SP_2017_NA0001_55_47_20170313_00038.jpg

LM Start	5.15	Rating **	M	Issue No.	47
LM End	5.15	Issue Type +	En	Location *	LS
Category	Earthen Levee			GPS Latitude/Longitude	
				Start	End
Item	Encroachments			38.580773 °	38.580773 °
				-121.426691 °	-121.426691 °
DWR ID	DWR_NA0001_04_s_2012_47				
Comment Code					
FE : Fence					
Inspector Comment					
Chain link fence, helix sky pencil, and landscaping within 10-ft of the levee toe obstruct access and visibility.

View of the fence and vegetation at the landside levee toe.

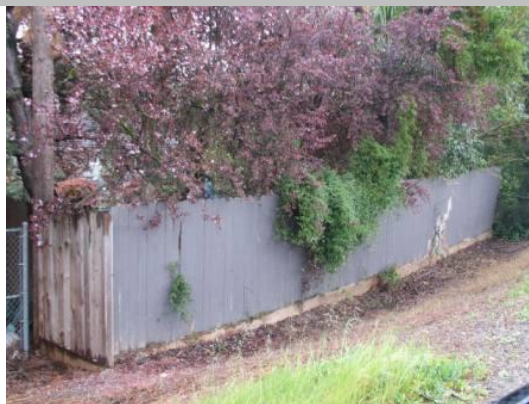
Photo 1 of 1 : SP_2017_NA0001_55_48_20170313_00039.jpg

LM Start	5.17	Rating **	U	Issue No.	48
LM End	5.17	Issue Type +	En	Location *	LS
Category	Earthen Levee			GPS Latitude/Longitude	
				Start	End
Item	Encroachments			38.580622 °	38.580622 °
				-121.426372 °	-121.426372 °
DWR ID	DWR_NA0001_04_s_2012_48				
Comment Code					
FE : Fence					
Inspector Comment					
Wood privacy fence and landscaping within 10-ft of the levee toe obstruct access and visibility.

03/16/2012 Wood privacy fence completely obstructs access and visibility.

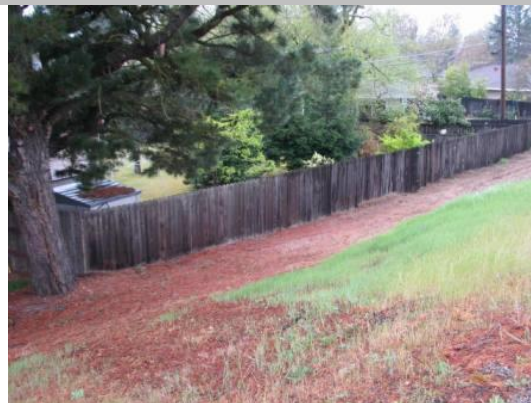
Photo 1 of 1 : SP_2017_NA0001_55_49_20170313_00040.jpg

LM Start	5.45	Rating **	U	Issue No.	49
LM End	5.45	Issue Type +	En	Location *	LS
Category	Earthen Levee			GPS Latitude/Longitude	
				Start	End
Item	Encroachments			38.577526 °	38.577526 °
				-121.423349 °	-121.423349 °
DWR ID	DWR_NA0001_04_s _ 2012_49				
Comment Code					
FE : Fence					
Inspector Comment					
Wood privacy fence within 10-ft of the levee toe obstruct access and visibility.

03/16/2012 Wood privacy fence completely obstructs access and visibility.

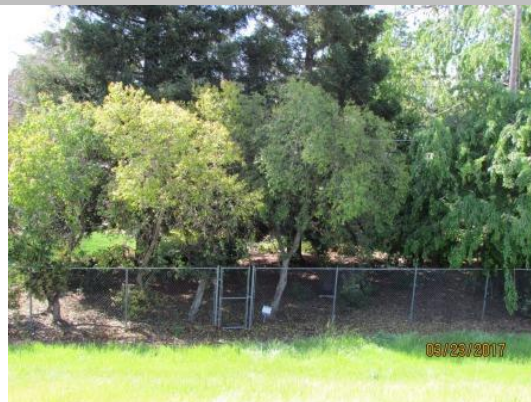
Photo 1 of 1 : SP_2017_NA0001_55_263_20170406_00271.jpg

LM Start	5.48	Rating **	M	Issue No.	263
LM End	5.48	Issue Type +	En	Location *	LS
Category	Earthen Levee			GPS Latitude/Longitude	
				Start	End
Item	Encroachments			38.577065 °	38.577065 °
				-121.423255 °	-121.423255 °
DWR ID	DWR_NA0001_04_s _ 2017_263				
Comment Code					
FE : Fence					
Inspector Comment					
Chain-link fence at levee toe.

View of the fence at the levee toe.

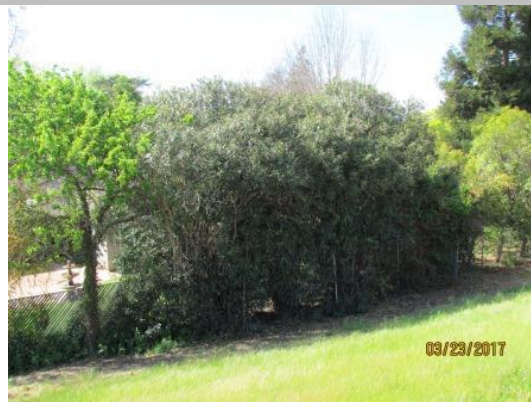
Photo 1 of 1 : SP_2017_NA0001_55_209_20170406_00270.jpg

LM Start	5.49	Rating **	M	Issue No.	209	
LM End	5.49	Issue Type +	En	Location *	LS	
Category	Earthen Levee			GPS Latitude/Longitude		
				Start		End
Item	Vegetation			38.576878 °		38.576878 °
				-121.423234 °		-121.423234 °
DWR ID	DWR_NA0001_04_s _ 2012_209					
Comment Code						
V6 : Landscaping						
Inspector Comment						
Oleanders within 10-ft of the levee toe obstruct access and visibility.

View of the shrubs at the levee toe.

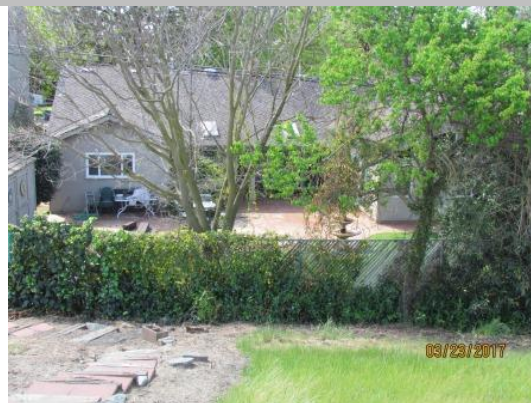
Photo 1 of 1 : SP_2017_NA0001_55_262_20170406_00269.jpg

LM Start	5.50	Rating **	U	Issue No.	262
LM End	5.50	Issue Type +	En	Location *	LS
Category	Earthen Levee			GPS Latitude/Longitude	
				Start	End
Item	Encroachments			38.576796 °	38.576796 °
				-121.423221 °	-121.423221 °
DWR ID	DWR_NA0001_04_s_2017_262				
Comment Code					
FE : Fence					
Inspector Comment					
Fence ubstructing visibility and access at landside levee toe.

View of the fence at the levee toe.

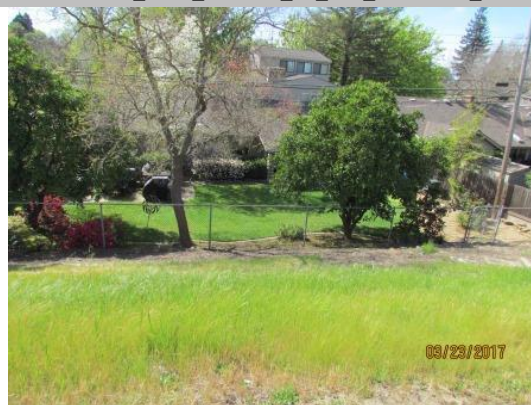
Photo 1 of 1 : SP_2017_NA0001_55_261_20170406_00268.jpg

LM Start	5.51	Rating **	M	Issue No.	261
LM End	5.51	Issue Type +	En	Location *	LS
Category	Earthen Levee			GPS Latitude/Longitude	
				Start	End
Item	Encroachments			38.576579 °	38.576579 °
				-121.423201 °	-121.423201 °
DWR ID	DWR_NA0001_04_s_2017_261				
Comment Code					
FE : Fence					
Inspector Comment					
Chain-link fence at levee toe.

View of the fence at the levee toe.

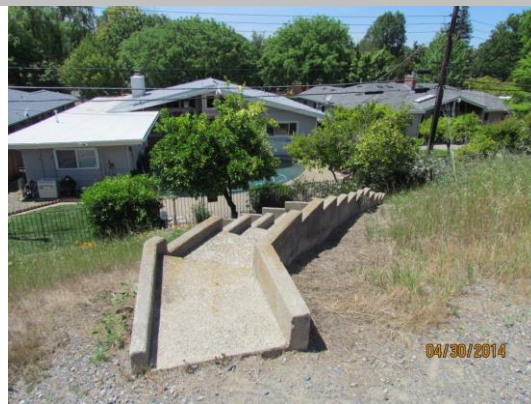
Photo 1 of 1 : SP_2017_NA0001_55_197_20170313_00164.jpg

LM Start	5.56	Rating **	U	Issue No.	197
LM End	5.56	Issue Type +	En	Location *	LS
Category	Earthen Levee			GPS Latitude/Longitude	
				Start	End
Item	Encroachments			38.575929 °	38.575929 °
				-121.423130 °	-121.423130 °
DWR ID	DWR_NA0001_04_s_2013_197				
Comment Code					
ST : Stairway					
Inspector Comment					
Unpermitted stairs to be removed by ARFCD.

View of the stairs on the landside levee slope.

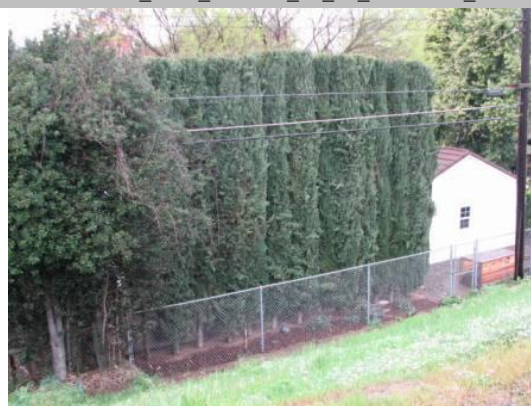
Photo 1 of 1 : SP_2017_NA0001_55_52_20170313_00042.jpg

LM Start	5.60	Rating **	U	Issue No.	52
LM End	5.60	Issue Type +	En	Location *	LS
Category	Earthen Levee			GPS Latitude/Longitude	
				Start	End
Item	Vegetation			38.575379 °	38.575379 °
				-121.423201 °	-121.423201 °
DWR ID	DWR_NA0001_04_s _ 2012_52				
Comment Code					
V6 : Landscaping					
Inspector Comment					
Helix sky pencil trees within 10-ft of the levee toe obstruct visibility and access.

03/16/2012 Landscaping obstructs visibility and access.

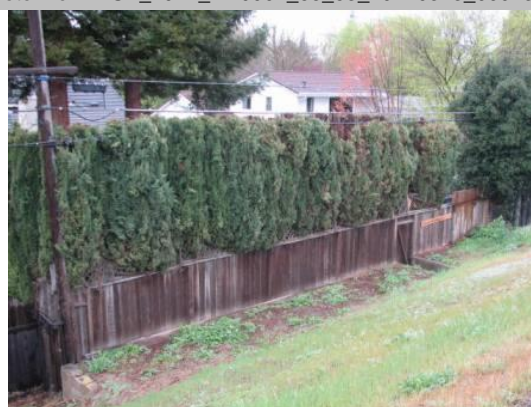
Photo 1 of 1 : SP_2017_NA0001_55_53_20170313_00043.jpg

LM Start	5.61	Rating **	U	Issue No.	53
LM End	5.61	Issue Type +	En	Location *	LS
Category	Earthen Levee			GPS Latitude/Longitude	
				Start	End
Item	Vegetation			38.575250 °	38.575250 °
				-121.423240 °	-121.423240 °
DWR ID	DWR_NA0001_04_s _ 2012_53				
Comment Code					
V6 : Landscaping					
Inspector Comment					
Wood privacy fence, helix sky pencil, vines and landscaping within 10-ft of the levee toe obstruct access and visibility. Cement stairs up levee slope.

03/16/2012 Landscaping and fence obstruct visibility and access.

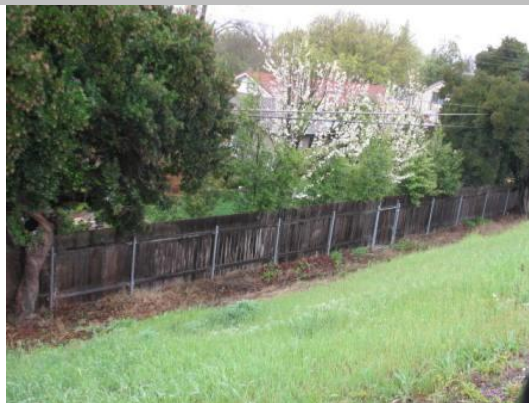
Photo 1 of 1 : SP_2017_NA0001_55_55_20170313_00045.jpg

LM Start	5.64	Rating **	U	Issue No.	55
LM End	5.64	Issue Type +	En	Location *	LS
Category	Earthen Levee			GPS Latitude/Longitude	
				Start	End
Item	Encroachments			38.574786 °	38.574786 °
				-121.423324 °	-121.423324 °
DWR ID	DWR_NA0001_04_s _ 2012_55				
Comment Code					
FE : Fence					
Inspector Comment					
Wood privacy fence within 10-ft of the levee toe obstructs visibility.

03/16/2012 Wood privacy fence completely obstructs access and visibility.

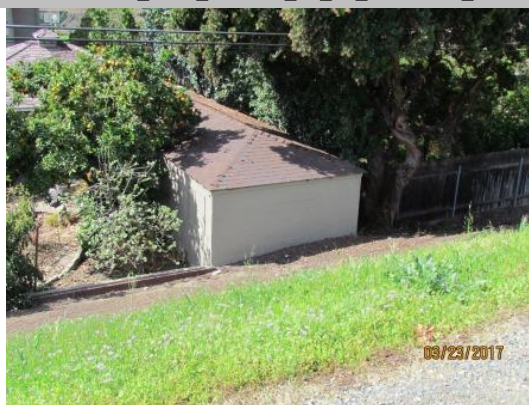
Photo 1 of 1 : SP_2017_NA0001_55_56_20170406_00267.jpg

LM Start	5.65	Rating **	U	Issue No.	56
LM End	5.65	Issue Type +	En	Location *	LS
Category	Earthen Levee			GPS Latitude/Longitude	
				Start	End
Item	Encroachments			38.574648 °	38.574648 °
				-121.423348 °	-121.423348 °
DWR ID	DWR_NA0001_04_s _ 2012_56				
Comment Code					
BU : Building					
Inspector Comment					
Cement block building on levee slope obstructs access.

View of the building at the levee toe.

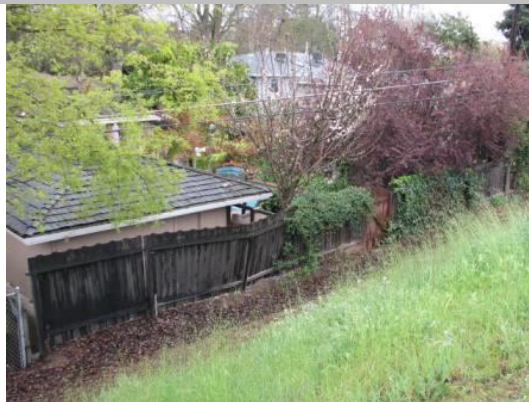
Photo 1 of 1 : SP_2017_NA0001_55_57_20170313_00047.jpg

LM Start	5.70	Rating **	U	Issue No.	57
LM End	5.70	Issue Type +	En	Location *	LS
Category	Earthen Levee			GPS Latitude/Longitude	
				Start	End
Item	Encroachments			38.573927 °	38.573927 °
				-121.423480 °	-121.423480 °
DWR ID	DWR_NA0001_04_s _ 2012_57				
Comment Code					
FE : Fence					
Inspector Comment					
Wood privacy fence with ivy obstructs visibility.

03/16/2012 Wood privacy fence completely obstructs access and visibility.

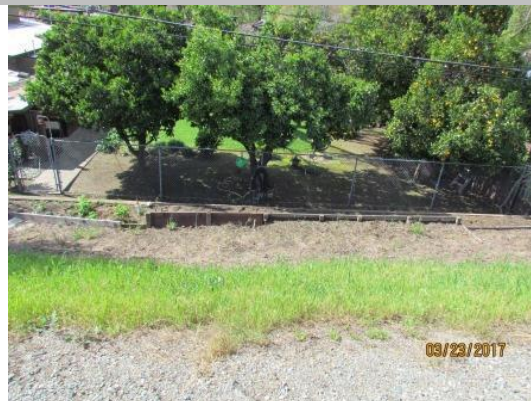
Photo 1 of 1 : SP_2017_NA0001_55_58_20170406_00266.jpg

LM Start	5.73	Rating **	M	Issue No.	58
LM End	5.73	Issue Type +	En	Location *	LS
Category	Earthen Levee			GPS Latitude/Longitude	
				Start	End
Item	Vegetation			38.573501 °	38.573501 °
				-121.423602 °	-121.423602 °
DWR ID	DWR_NA0001_04_s_2012_58				
Comment Code					
V6 : Landscaping					
Inspector Comment					
Garden built on levee slope.

View of the garden at the levee toe.

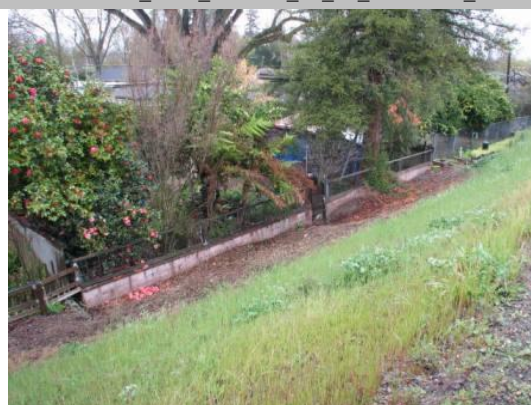
Photo 1 of 1 : SP_2017_NA0001_55_59_20170313_00048.jpg

LM Start	5.73	Rating **	U	Issue No.	59
LM End	5.73	Issue Type +	En	Location *	LS
Category	Earthen Levee			GPS Latitude/Longitude	
				Start	End
Item	Encroachments			38.573403 °	38.573403 °
				-121.423642 °	-121.423642 °
DWR ID	DWR_NA0001_04_s_2012_59				
Comment Code					
FE : Fence					
Inspector Comment					
Brick fence and landscaping within 10-ft of the levee toe obstructs access and visibility.

03/16/2012 Fence and landscaping obstruct visibility and access.

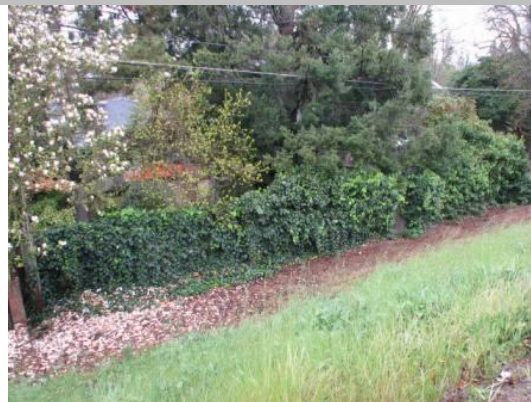
Photo 1 of 1 : SP_2017_NA0001_55_61_20170313_00049.jpg

LM Start	5.78	Rating **	U	Issue No.	61
LM End	5.78	Issue Type +	En	Location *	LS
Category	Earthen Levee			GPS Latitude/Longitude	
				Start	End
Item	Vegetation			38.572827 °	38.572827 °
				-121.423786 °	-121.423786 °
DWR ID	DWR_NA0001_04_s_2012_61				
Comment Code					
V6 : Landscaping					
Inspector Comment					
Dense ivy and shrubs are within 10-ft of the levee toe.

03/16/2012 Landscaping obstructs access and visibility.

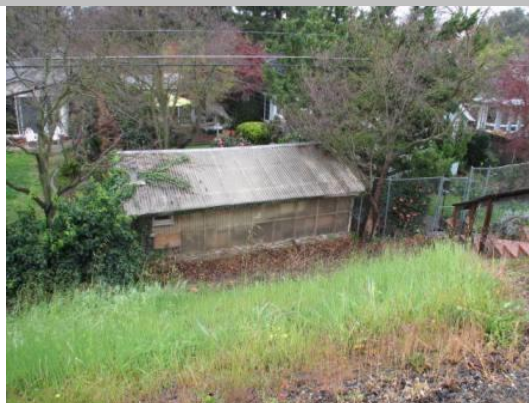
Photo 1 of 1 : SP_2017_NA0001_55_63_20170313_00050.jpg

LM Start	5.81	Rating **	U	Issue No.	63
LM End	5.81	Issue Type +	En	Location *	LS
Category	Earthen Levee			GPS Latitude/Longitude	
				Start	End
Item	Encroachments			38.572325 °	38.572325 °
				-121.423913 °	-121.423913 °
DWR ID	DWR_NA0001_04_s _ 2012_63				
Comment Code					
BU : Building					
Inspector Comment					
Wood and fiberglass structure within 10-ft of the levee toe.

03/16/2012 Wood and fiberglass structure is within 15' of levee toe.

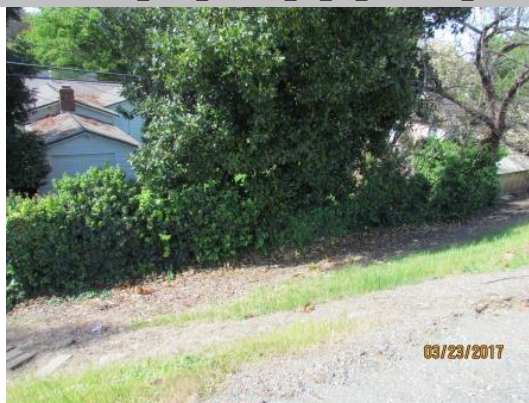
Photo 1 of 1 : SP_2017_NA0001_55_64_20170406_00265.jpg

LM Start	5.82	Rating **	M	Issue No.	64
LM End	5.82	Issue Type +	En	Location *	LS
Category	Earthen Levee			GPS Latitude/Longitude	
				Start	End
Item	Vegetation			38.572207 °	38.572207 °
				-121.423933 °	-121.423933 °
DWR ID	DWR_NA0001_04_s _ 2012_64				
Comment Code					
V6 : Landscaping					
Inspector Comment					
Dense shrubs on levee toe obstruct visibility and access.

View of the shrubs at the levee toe.

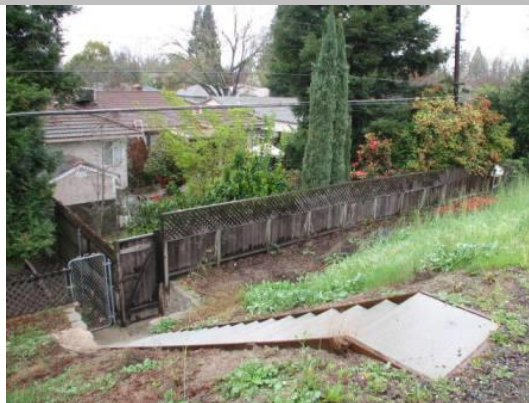
Photo 1 of 1 : SP_2017_NA0001_55_65_20170313_00051.jpg

LM Start	5.83	Rating **	U	Issue No.	65
LM End	5.83	Issue Type +	En	Location *	LS
Category	Earthen Levee			GPS Latitude/Longitude	
				Start	End
Item	Encroachments			38.572067 °	38.572067 °
				-121.423970 °	-121.423970 °
DWR ID	DWR_NA0001_04_s_2012_65				
Comment Code					
FE : Fence					
Inspector Comment					
Extended privacy fence and retaining wall within 10-ft of levee toe.

03/16/2012 Wood privacy fence completely obstructs access and visibility.

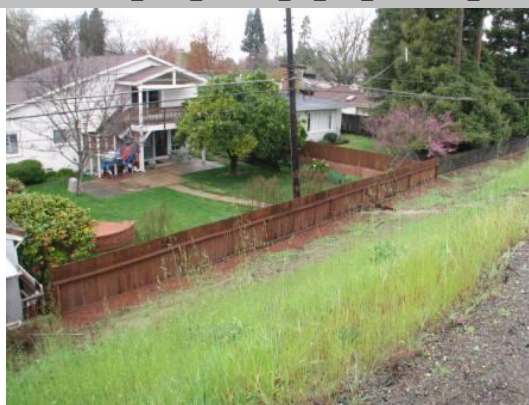
Photo 1 of 1 : SP_2017_NA0001_55_210_20170313_00172.jpg

LM Start	5.85	Rating **	U	Issue No.	210
LM End	5.85	Issue Type +	En	Location *	LS
Category	Earthen Levee			GPS Latitude/Longitude	
				Start	End
Item	Encroachments			38.571733 °	38.571733 °
				-121.424055 °	-121.424055 °
DWR ID	DWR_NA0001_04_s_2012_210				
Comment Code					
FE : Fence					
Inspector Comment					
Privacy fence and retaining wall are within 10-ft of levee toe.

03/16/2012 Wood privacy fence completely obstructs access and visibility.

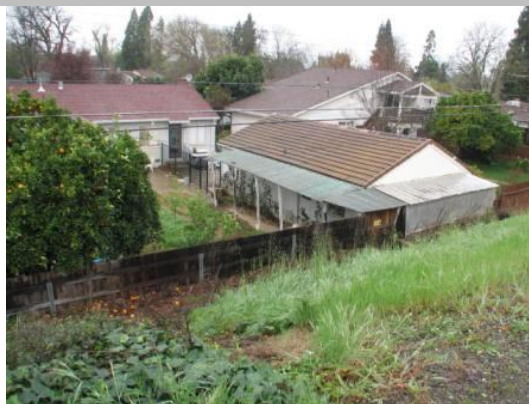
Photo 1 of 1 : SP_2017_NA0001_55_66_20170313_00052.jpg

LM Start	5.86	Rating **	U	Issue No.	66
LM End	5.86	Issue Type +	En	Location *	LS
Category	Earthen Levee			GPS Latitude/Longitude	
				Start	End
Item	Encroachments			38.571586 °	38.571586 °
				-121.424097 °	-121.424097 °
DWR ID	DWR_NA0001_04_s_2012_66				
Comment Code					
BU : Building					
Inspector Comment

03/16/2012 Structure is within 15' of levee toe.

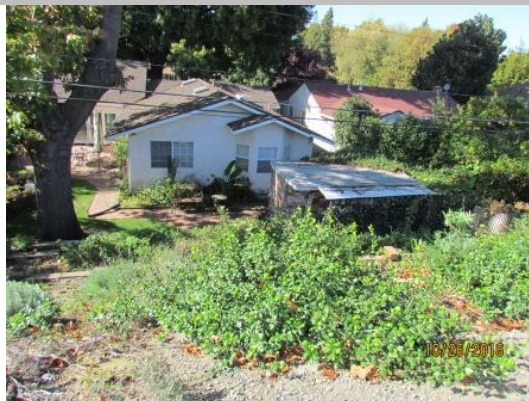
Photo 1 of 1 : SP_2017_NA0001_55_68_20170313_00053.jpg

LM Start	5.87	Rating **	U	Issue No.	68
LM End	5.87	Issue Type +	En	Location *	LS
Category	Earthen Levee			GPS Latitude/Longitude	
				Start	End
Item	Vegetation			38.571525 °	38.571525 °
				-121.424152 °	-121.424152 °
DWR ID	DWR_NA0001_04_f_2013_68				
Comment Code					
V6 : Landscaping					
Inspector Comment					
Levee slope has been landscaped. This obstructs visibility.

Levee slope is heavily landscaped, retaining wall has been constructed at the levee toe.

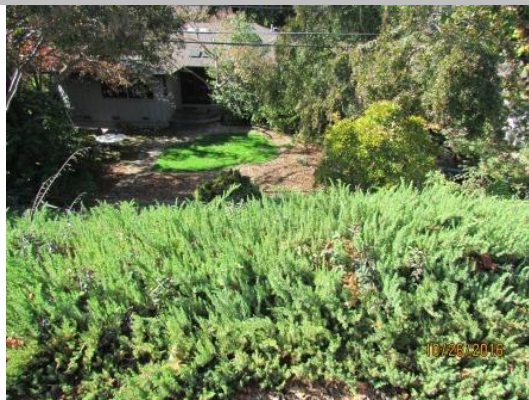
Photo 1 of 1 : SP_2017_NA0001_55_70_20170313_00054.jpg

LM Start	5.88	Rating **	U	Issue No.	70
LM End	5.88	Issue Type +	En	Location *	LS
Category	Earthen Levee			GPS Latitude/Longitude	
				Start	End
Item	Vegetation			38.571269 °	38.571269 °
				-121.424167 °	-121.424167 °
DWR ID	DWR_NA0001_04_s_2012_70				
Comment Code					
V6 : Landscaping					
Inspector Comment					
Levee slope has been landscaped. This obstructs visibility.

View of the vegetation on the landside levee slope.

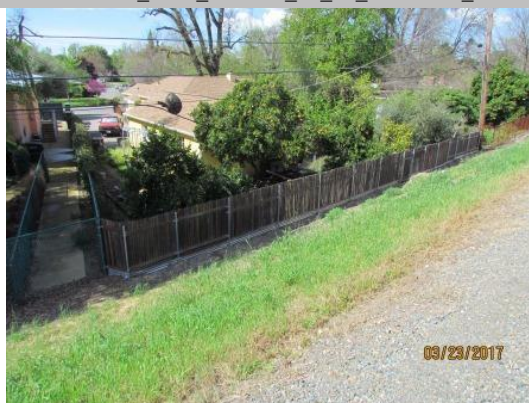
Photo 1 of 1 : SP_2017_NA0001_55_88_20170406_00264.jpg

LM Start	5.91	Rating **	U	Issue No.	88
LM End	5.91	Issue Type +	En	Location *	LS
Category	Earthen Levee			GPS Latitude/Longitude	
				Start	End
Item	Encroachments			38.570864 °	38.570864 °
				-121.424212 °	-121.424212 °
DWR ID	DWR_NA0001_04_f_2012_88				
Comment Code					
FE : Fence					
Inspector Comment					
Wooden privacy fence.

View of the wood privacy fence completely obstructing access and visibility.

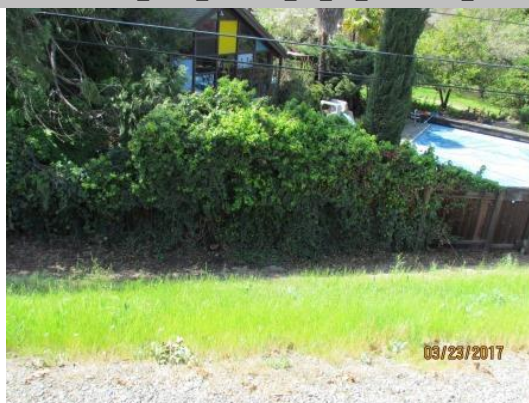
Photo 1 of 1 : SP_2017_NA0001_55_72_20170406_00263.jpg

LM Start	5.95	Rating **	U	Issue No.	72
LM End	5.95	Issue Type +	En	Location *	LS
Category	Earthen Levee			GPS Latitude/Longitude	
				Start	End
Item	Encroachments			38.570389 °	38.570389 °
				-121.424231 °	-121.424231 °
DWR ID	DWR_NA0001_04_s_2012_72				
Comment Code					
FE : Fence					
Inspector Comment					
Wood fence and landscaping within 10-ft of the levee toe obstructs visibility.

View of the wood privacy fence completely obstructing access and visibility.

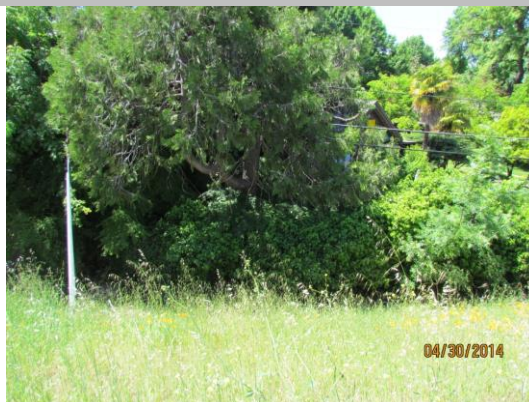
Photo 1 of 1 : SP_2017_NA0001_55_71_20170313_00055.jpg

LM Start	5.95	Rating **	M	Issue No.	71
LM End	5.95	Issue Type +	En	Location *	LS
Category	Earthen Levee			GPS Latitude/Longitude	
				Start	End
Item	Vegetation			38.570375 °	38.570375 °
				-121.424231 °	-121.424231 °
DWR ID	DWR_NA0001_04_s_2012_71				
Comment Code					
V6 : Landscaping					
Inspector Comment					
Landscaping and garden within 10-ft of the levee toe.

View of the landscaping at the landside levee toe.

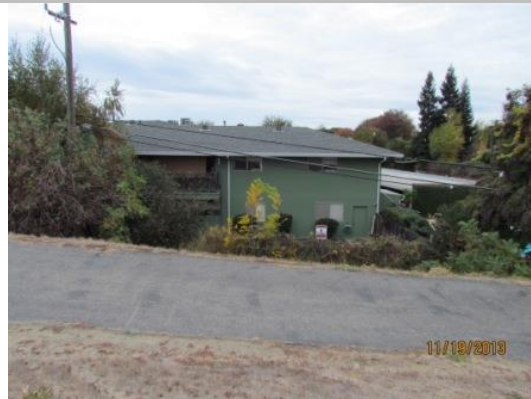
Photo 1 of 1 : SP_2017_NA0001_55_211_20170313_00173.jpg

LM Start	5.98	Rating **	M	Issue No.	211
LM End	5.98	Issue Type +	En	Location *	LS
Category	Earthen Levee			GPS Latitude/Longitude	
				Start	End
Item	Encroachments			38.569893 °	38.569893 °
				-121.424310 °	-121.424310 °
DWR ID	DWR_NA0001_04_s_2012_211				
Comment Code					
FE : Fence					
Inspector Comment					
Apartment complex privacy fence and shrubs within 10-ft of the slope obstruct visibility.

View of the fence at the landside levee toe.

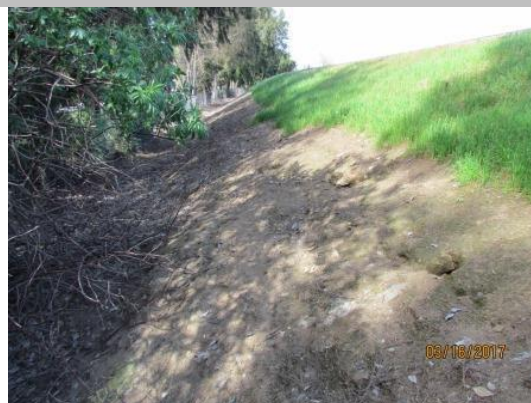
Photo 1 of 1 : SP_2017_NA0001_55_260_20170406_00262.jpg

LM Start	6.24	Rating **	U	Issue No.	260
LM End	6.24	Issue Type +	Ma	Location *	LS
Category	Earthen Levee			GPS Latitude/Longitude	
				Start	End
Item	Animal Control			38.566220 °	38.566220 °
				-121.423558 °	-121.423558 °
DWR ID	DWR_NA0001_04_s_2017_260				
Comment Code					
A1 : Exterminate rodents and backfill and compact or grout burrows.					
Inspector Comment

View of the rodent burrows at the levee toe.

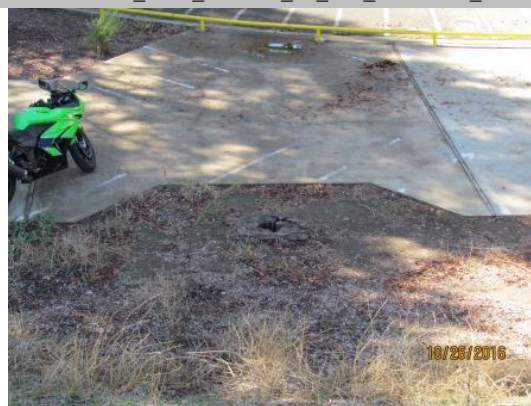
Photo 1 of 1 : SP_2017_NA0001_55_238_20170313_00184.jpg

LM Start	6.45	Rating **	N	Issue No.	238
LM End	6.45	Issue Type +	Ma	Location *	LS
Category	Earthen Levee			GPS Latitude/Longitude	
				Start	End
Item	Trim / Thin Trees			38.563231 °	38.563231 °
				-121.422404 °	-121.422404 °
DWR ID	DWR_NA0001_04_f_2015_238				
Comment Code					
T5 : Tree stumps.					
Inspector Comment

View of the tree stump at the landside levee toe.

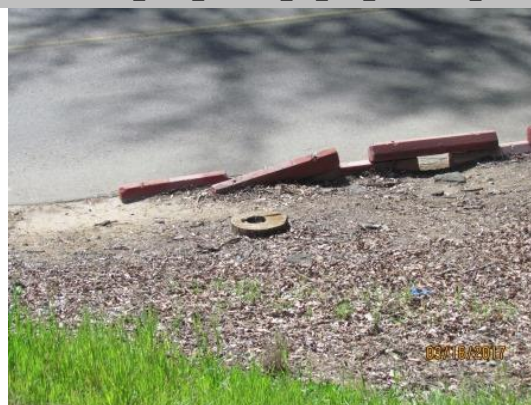
Photo 1 of 1 : SP_2017_NA0001_55_233_20170406_00261.jpg

LM Start	6.49	Rating **	N	Issue No.	233
LM End	6.49	Issue Type +	Ma	Location *	LS
Category	Earthen Levee			GPS Latitude/Longitude	
				Start	End
Item	Trim / Thin Trees			38.562659 °	38.562659 °
				-121.422122 °	-121.422122 °
DWR ID	DWR_NA0001_04_f_2015_233				
Comment Code					
T5 : Tree stumps.					
Inspector Comment

View of the tree stump at the levee toe.

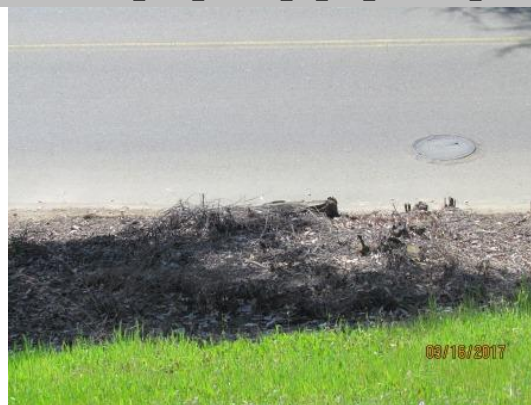
Photo 1 of 1 : SP_2017_NA0001_55_256_20170406_00260.jpg

LM Start	6.52	Rating **	N	Issue No.	256
LM End	6.52	Issue Type +	Ma	Location *	LS
Category	Earthen Levee			GPS Latitude/Longitude	
				Start	End
Item	Trim / Thin Trees			38.562347 °	38.562347 °
				-121.421905 °	-121.421905 °
DWR ID	DWR_NA0001_04_s_2017_256				
Comment Code					
T5 : Tree stumps.					
Inspector Comment					
Stump at levee toe.

View of the stump at the levee toe.

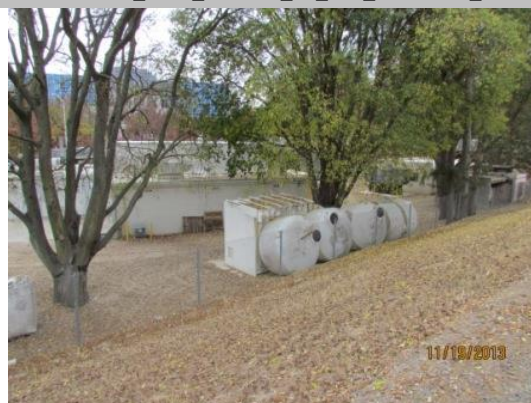
Photo 1 of 1 : SP_2017_NA0001_55_185_20170313_00156.jpg

LM Start	6.60	Rating **	M	Issue No.	185
LM End	6.60	Issue Type +	En	Location *	LS
Category	Earthen Levee			GPS Latitude/Longitude	
				Start	End
Item	Encroachments			38.561448 °	38.561448 °
				-121.421071 °	-121.421071 °
DWR ID	DWR_NA0001_04_f_2013_185				
Comment Code					
TA : Tank					
Inspector Comment					
5 water tanks and storage shed within 10 feet of landside levee toe.

View of the water tanks stored at the landside levee toe.

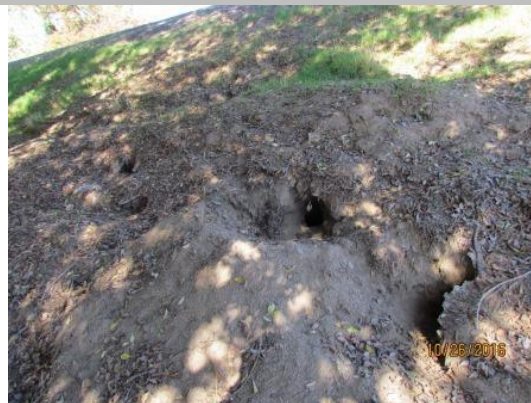
Photo 1 of 2 : SP_2017_NA0001_55_240_20170313_00185.jpg

LM Start	6.62	Rating **	U	Issue No.	240
LM End	6.65	Issue Type +	Ma	Location *	LS
Category	Earthen Levee			GPS Latitude/Longitude	
				Start	End
Item	Animal Control			38.561121 °	38.560883 °
				-121.420766 °	-121.420514 °
DWR ID	DWR_NA0001_04_s_2017_240				
Comment Code					
A1 : Exterminate rodents and backfill and compact or grout burrows.					
Inspector Comment					
LMA backfilled the rodent burrows.

View of a rodent burrows at the landside levee toe.

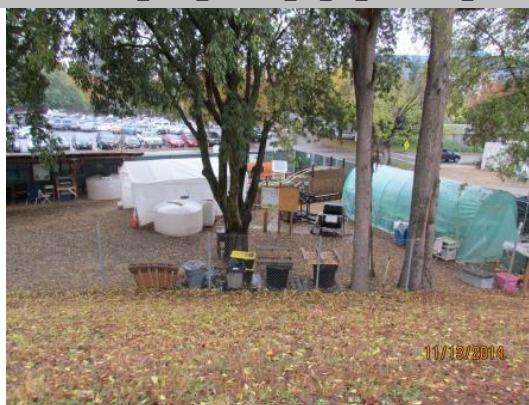
Photo 1 of 1 : SP_2017_NA0001_55_51_20170313_00041.jpg

LM Start	6.62	Rating **	M	Issue No.	51
LM End	6.62	Issue Type +	En	Location *	LS
Category	Earthen Levee			GPS Latitude/Longitude	
				Start	End
Item	Encroachments			38.561117 °	38.561117 °
				-121.420749 °	-121.420749 °
DWR ID	DWR_NA0001_04_f_2013_51				
Comment Code					
MA : Material					
Inspector Comment					
Pipe and other material stored within 10 feet of landside levee toe.

View of the material stored at the landside levee toe.

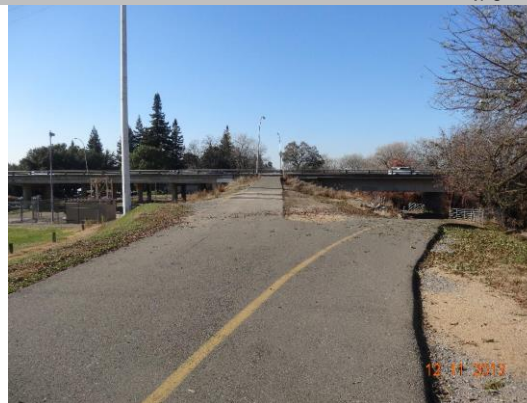
Photo 1 of 3 : UCIP_SP_2017_30023_55394.jpg

Comment Code					
Inspector Comment					
FS_ID:30023 DS_ID:24319 EP_NO: 3596 Repair Type: Non-Urgent Crossing Status: Indicator Found UCIP Comments: Need to contact owners to determine how crossing was abandoned. FIELD_STRUCT_DESC: *ABANDONED* [Power Inn Road Plant] 4 of 4: 48-inch corrugated metal (CM) drainpipe through the levee, 20.0 feet below the crown. Two CM cutoff walls around pipe under each shoulder. Slide gate with control pedestal in CM pipe riser on waterside (WS) slope. Slide gate with control pedestal in collection sump on landside (LS). Pumping plant at LS toe. Reinforced concrete discharge box at the toe of the WS slope. Flap gate on WS end. (Permit No. 3596-1962) 60-inch discharge pipe from box across the berm to the riverbank installed under Permit No. 5894 (1970). Pipe abandoned and CM pipe riser cut 2.0 feet below ground surface under Permit No. 3596A (1998). FS Date: 12/11/2013

Overview of levee crown at crossings.

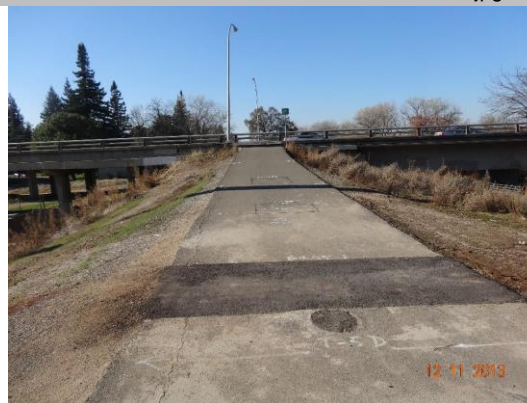
Photo 2 of 3 : UCIP_SP_2017_30023_55392.jpg

Signs of crossing repair patch section visible on levee crown.

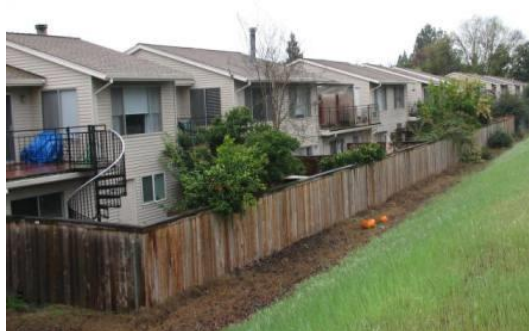
Photo 1 of 1 : SP_2017_NA0001_55_75_20170313_00059.jpg

LM Start	7.69	Rating **	U	Issue No.	75
LM End	7.72	Issue Type +	En	Location *	LS
Category	Earthen Levee			GPS Latitude/Longitude	
				Start	End
Item	Encroachments			38.559230 °	38.559261 °
				-121.402708 °	-121.402219 °
DWR ID	DWR_NA0001_04_s _ 2012_75				
Comment Code					
FE : Fence					
Inspector Comment					
Wooden privacy fence for seven apartment units is within 10-ft of levee toe and obstructs access and visibility.

03/16/2012 Wood privacy fence completely obstructs access and visibility.

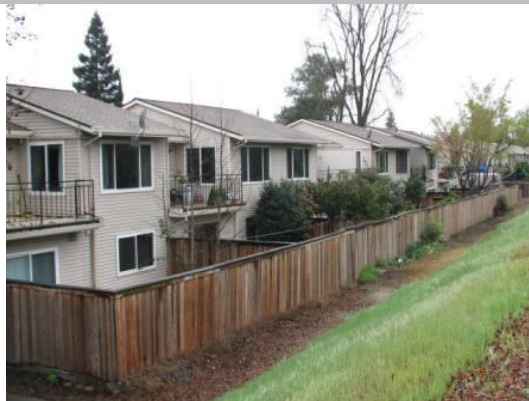
Photo 1 of 1 : SP_2017_NA0001_55_76_20170313_00060.jpg

LM Start	7.75	Rating **	U	Issue No.	76
LM End	7.76	Issue Type +	En	Location *	LS
Category	Earthen Levee			GPS Latitude/Longitude	
				Start	End
Item	Encroachments			38.559308 °	38.559309 °
				-121.401717 °	-121.401388 °
DWR ID	DWR_NA0001_04_s _ 2012_76				
Comment Code					
FE : Fence					
Inspector Comment					
Wooden privacy fence for seven apartment units is within 10-ft of levee toe and obstructs access and visibility.

03/16/2012 Wood privacy fence completely obstructs access and visibility.

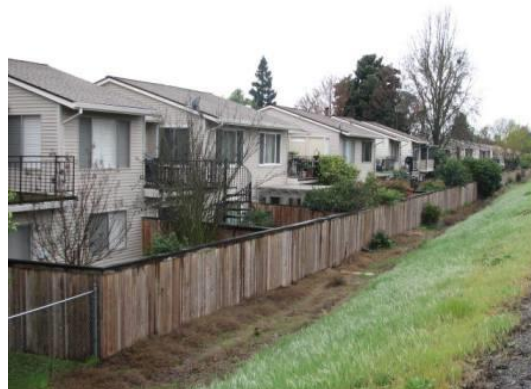
Photo 1 of 1 : SP_2017_NA0001_55_77_20170313_00061.jpg

LM Start	7.78	Rating **	U	Issue No.	77
LM End	7.80	Issue Type +	En	Location *	LS
Category	Earthen Levee			GPS Latitude/Longitude	
				Start	End
Item	Encroachments			38.559330 °	38.559366 °
				-121.401162 °	-121.400683 °
DWR ID	DWR_NA0001_04_s_2012_77				
Comment Code					
FE : Fence					
Inspector Comment					
Wooden privacy fence for seven apartment units is within 10-ft of levee toe and obstructs access and visibility.

03/16/2012 Wood privacy fence completely obstructs access and visibility.

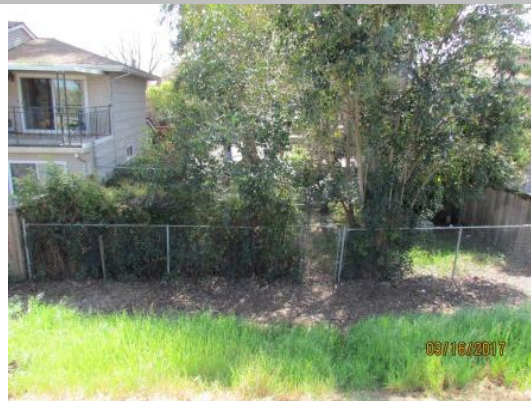
Photo 1 of 1 : SP_2017_NA0001_55_255_20170406_00257.jpg

LM Start	7.81	Rating **	M	Issue No.	255
LM End	7.81	Issue Type +	En	Location *	LS
Category	Earthen Levee			GPS Latitude/Longitude	
				Start	End
Item	Vegetation			38.559368 °	38.559368 °
				-121.400469 °	-121.400469 °
DWR ID	DWR_NA0001_04_s_2017_255				
Comment Code					
V6 : Landscaping					
Inspector Comment					
Shrubs blocking visibility.

View of the shrubs at the levee toe.

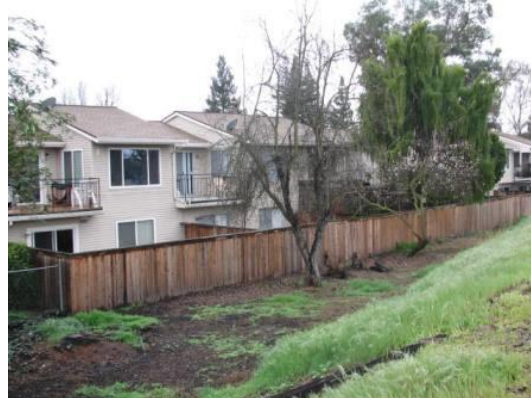
Photo 1 of 1 : SP_2017_NA0001_55_78_20170313_00062.jpg

LM Start	7.82	Rating **	U	Issue No.	78
LM End	7.84	Issue Type +	En	Location *	LS
Category	Earthen Levee			GPS Latitude/Longitude	
				Start	End
Item	Encroachments			38.559379 °	38.559435 °
				-121.400354 °	-121.399944 °
DWR ID	DWR_NA0001_04_s_2017_78				
Comment Code					
FE : Fence					
Inspector Comment					
Wooden privacy fence for seven apartment units is within 10-ft of levee toe and obstructs access and visibility.

03/16/2012 Wood privacy fence completely obstructs access and visibility.

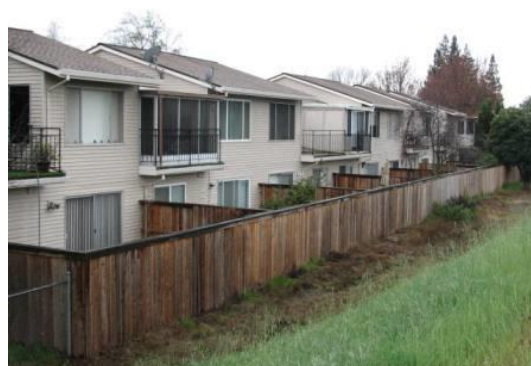
Photo 1 of 1 : SP_2017_NA0001_55_79_20170313_00063.jpg

LM Start	7.86	Rating **	U	Issue No.	79
LM End	7.88	Issue Type +	En	Location *	LS
Category	Earthen Levee			GPS Latitude/Longitude	
				Start	End
Item	Encroachments			38.559514 °	38.559643 °
				-121.399700 °	-121.399248 °
DWR ID	DWR_NA0001_04_s _ 2012_79				
Comment Code					
FE : Fence					
Inspector Comment					
Wooden privacy fence for seven apartment units is within 10-ft of levee toe and obstructs access and visibility.

03/16/2012 Wood privacy fence completely obstructs access and visibility.

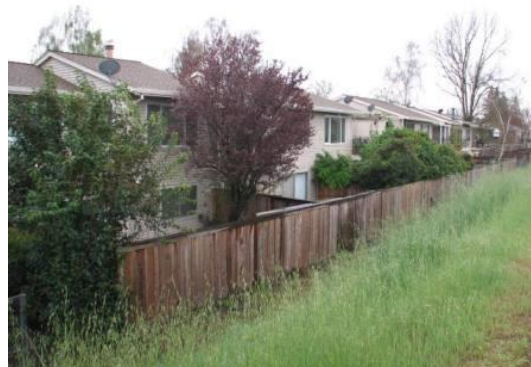
Photo 1 of 1 : SP_2017_NA0001_55_80_20170313_00064.jpg

LM Start	7.90	Rating **	U	Issue No.	80
LM End	7.93	Issue Type +	En	Location *	LS
Category	Earthen Levee			GPS Latitude/Longitude	
				Start	End
Item	Encroachments			38.559753 °	38.559911 °
				-121.398982 °	-121.398506 °
DWR ID	DWR_NA0001_04_s _ 2012_80				
Comment Code					
FE : Fence					
Inspector Comment					
Wooden privacy fence for seven apartment units is within 10-ft of levee toe and obstructs access and visibility.

03/16/2012 Wood privacy fence completely obstructs access and visibility.

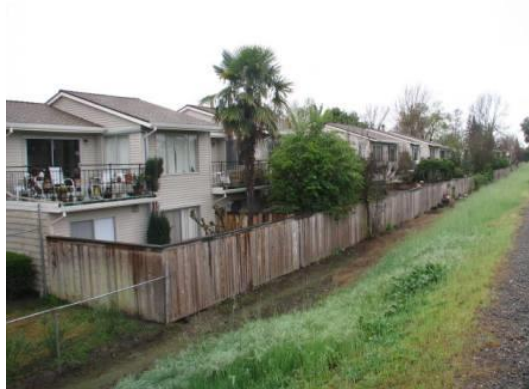
Photo 1 of 2 : SP_2017_NA0001_55_224_20170313_00175.jpg

LM Start	7.94	Rating **	U	Issue No.	224
LM End	8.02	Issue Type +	En	Location *	LS
Category	Earthen Levee			GPS Latitude/Longitude	
				Start	End
Item	Encroachments			38.559968 °	38.560505 °
				-121.398330 °	-121.396989 °
DWR ID	DWR_NA0001_04_s_2012_224				
Comment Code					
FE : Fence					
Inspector Comment					
Wooden privacy fence for seven apartment units is within 10-ft of levee toe and obstructs access and visibility.

03/16/2012 Wood privacy fence completely obstructs access and visibility.

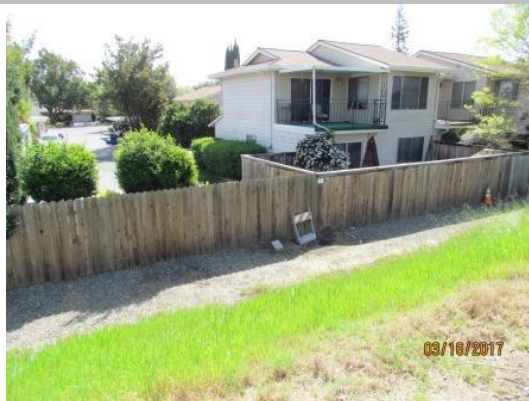
Photo 2 of 2 : SP_2017_NA0001_55_224_20170406_00258.jpg

Another view of the fence at the levee toe.

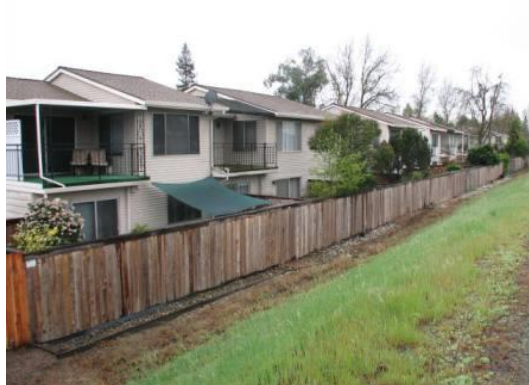
Photo 1 of 1 : SP_2017_NA0001_55_81_20170313_00065.jpg

LM Start	7.98	Rating **	U	Issue No.	81
LM End	8.00	Issue Type +	En	Location *	LS
Category	Earthen Levee			GPS Latitude/Longitude	
				Start	End
Item	Encroachments			38.560281 °	38.560435 °
				-121.397604 °	-121.397239 °
DWR ID	DWR_NA0001_04_s _ 2012_81				
Comment Code					
FE : Fence					
Inspector Comment					
Wooden privacy fence for seven apartment units is within 10-ft of levee toe and obstructs access and visibility.

03/16/2012 Wood privacy fence completely obstructs access and visibility.

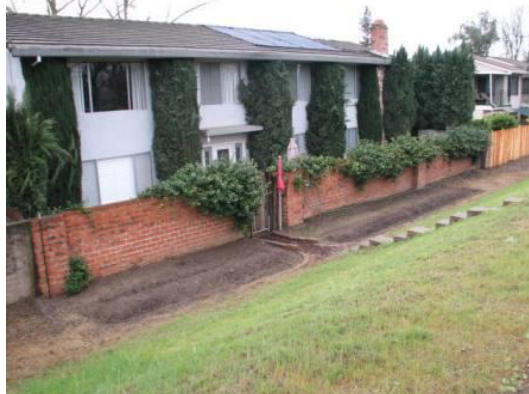
Photo 1 of 1 : SP_2017_NA0001_55_82_20170313_00066.jpg

LM Start	8.02	Rating **	U	Issue No.	82
LM End	8.02	Issue Type +	En	Location *	LS
Category	Earthen Levee			GPS Latitude/Longitude	
				Start	End
Item	Encroachments			38.560537 °	38.560537 °
				-121.396912 °	-121.396912 °
DWR ID	DWR_NA0001_04_s _ 2012_82				
Comment Code					
FE : Fence					
Inspector Comment					
Brick fence is within 10-ft of levee toe, obstructing access and visibility.

03/16/2012 Brick wall completely obstructs access and visibility.

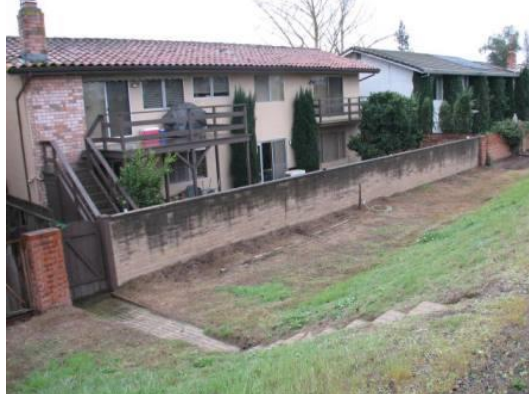
Photo 1 of 1 : SP_2017_NA0001_55_83_20170313_00067.jpg

LM Start	8.04	Rating **	U	Issue No.	83
LM End	8.04	Issue Type +	En	Location *	LS
Category	Earthen Levee			GPS Latitude/Longitude	
				Start	End
Item	Encroachments			38.560647 °	38.560647 °
				-121.396660 °	-121.396660 °
DWR ID	DWR_NA0001_04_s _ 2012_83				
Comment Code					
FE : Fence					
Inspector Comment					
Brick fence is within 10-ft of levee toe and obstructs access and visibility.

03/16/2012 Brick wall completely obstructs access and visibility.

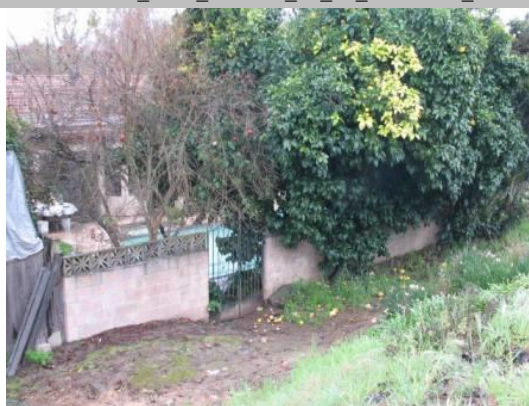
Photo 1 of 1 : SP_2017_NA0001_55_92_20170313_00076.jpg

LM Start	8.19	Rating **	U	Issue No.	92
LM End	8.19	Issue Type +	En	Location *	LS
Category	Earthen Levee			GPS Latitude/Longitude	
				Start	End
Item	Encroachments			38.561658 °	38.561658 °
				-121.394157 °	-121.394157 °
DWR ID	DWR_NA0001_04_s _ 2012_92				
Comment Code					
FE : Fence					
Inspector Comment					
Cement block fence and landscaping within 10-ft of levee toe obstructs access and visibility.

03/16/2012 Cinder block fence completely obstructs access and visibility.

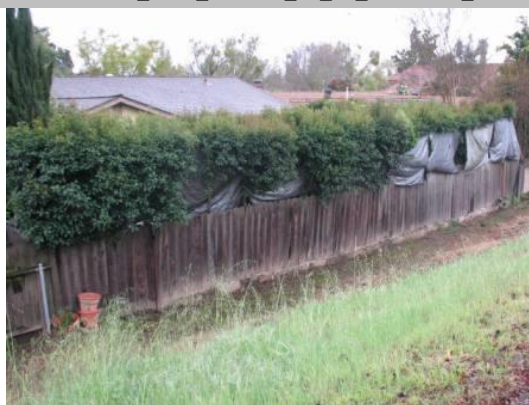
Photo 1 of 1 : SP_2017_NA0001_55_93_20170313_00077.jpg

LM Start	8.21	Rating **	U	Issue No.	93
LM End	8.21	Issue Type +	En	Location *	LS
Category	Earthen Levee			GPS Latitude/Longitude	
				Start	End
Item	Encroachments			38.561750 °	38.561750 °
				-121.393917 °	-121.393917 °
DWR ID	DWR_NA0001_04_s _ 2012_93				
Comment Code					
FE : Fence					
Inspector Comment					
Wooden fence, strung tarps, and landscaping within 10-ft of levee toe obstructs access and visibility.

03/16/2012 Wood privacy fence completely obstructs access and visibility.

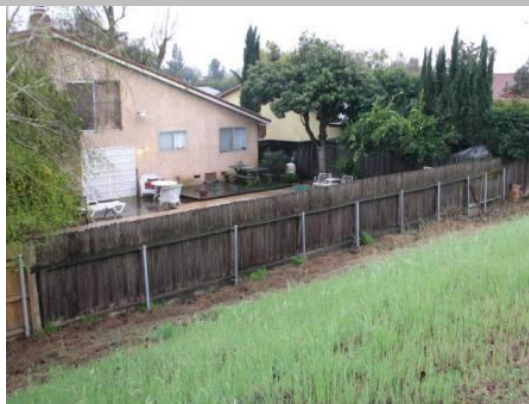
Photo 1 of 1 : SP_2017_NA0001_55_94_20170313_00078.jpg

LM Start	8.21	Rating **	U	Issue No.	94
LM End	8.21	Issue Type +	En	Location *	LS
Category	Earthen Levee			GPS Latitude/Longitude	
				Start	End
Item	Encroachments			38.561799 °	38.561799 °
				-121.393758 °	-121.393758 °
DWR ID	DWR_NA0001_04_s _ 2012_94				
Comment Code					
FE : Fence					
Inspector Comment					
Wood privacy fence and pool within 10-ft of levee toe obstructs access and visibility.

03/16/2012 Wood privacy fence completely obstructs access and visibility.

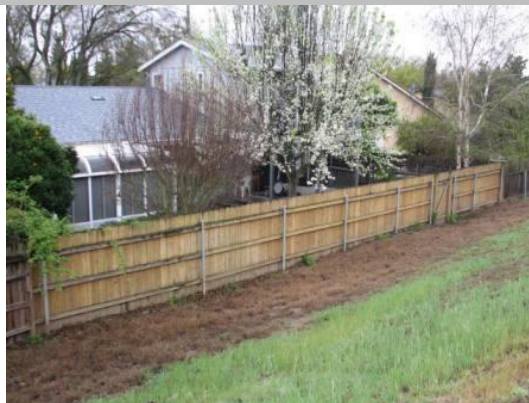
Photo 1 of 1 : SP_2017_NA0001_55_95_20170313_00079.jpg

LM Start	8.23	Rating **	U	Issue No.	95
LM End	8.23	Issue Type +	En	Location *	LS
Category	Earthen Levee			GPS Latitude/Longitude	
				Start	End
Item	Encroachments			38.561900 °	38.561900 °
				-121.393547 °	-121.393547 °
DWR ID	DWR_NA0001_04_s _ 2012_95				
Comment Code					
FE : Fence					
Inspector Comment					
Wood privacy fence within 10-ft of levee toe obstructs access and visibility.

03/16/2012 Wood privacy fence completely obstructs access and visibility.

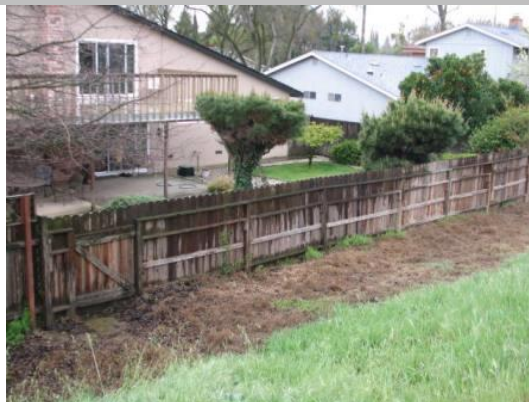
Photo 1 of 1 : SP_2017_NA0001_55_97_20170313_00081.jpg

LM Start	8.24	Rating **	U	Issue No.	97
LM End	8.24	Issue Type +	En	Location *	LS
Category	Earthen Levee			GPS Latitude/Longitude	
				Start	End
Item	Encroachments			38.561977 °	38.561977 °
				-121.393338 °	-121.393338 °
DWR ID	DWR_NA0001_04_s _ 2017_97				
Comment Code					
FE : Fence					
Inspector Comment					
Wood privacy fence within 10-ft of levee toe obstructs access and visibility.

03/16/2012 Wood privacy fence completely obstructs access and visibility.

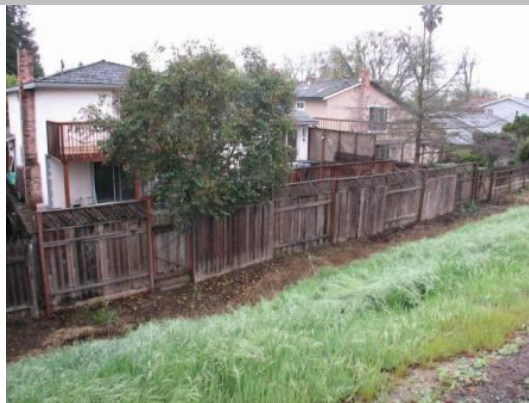
Photo 1 of 1 : SP_2017_NA0001_55_98_20170313_00082.jpg

LM Start	8.25	Rating **	U	Issue No.	98
LM End	8.25	Issue Type +	En	Location *	LS
Category	Earthen Levee			GPS Latitude/Longitude	
				Start	End
Item	Encroachments			38.562054 °	38.562054 °
				-121.393190 °	-121.393190 °
DWR ID	DWR_NA0001_04_s_2012_98				
Comment Code					
FE : Fence					
Inspector Comment					
Wood privacy fence within 10-ft of levee toe obstructs access and visibility.

03/16/2012 Wood privacy fence completely obstructs access and visibility.

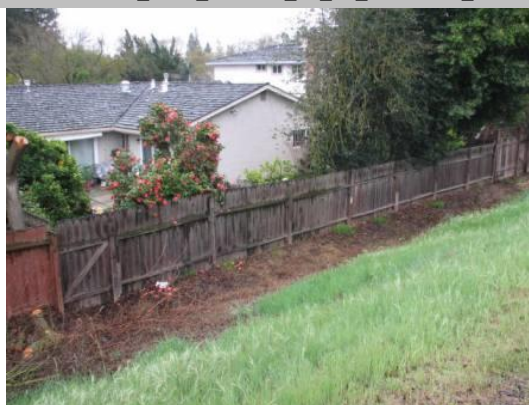
Photo 1 of 1 : SP_2017_NA0001_55_99_20170313_00083.jpg

LM Start	8.26	Rating **	U	Issue No.	99
LM End	8.26	Issue Type +	En	Location *	LS
Category	Earthen Levee			GPS Latitude/Longitude	
				Start	End
Item	Encroachments			38.562120 °	38.562120 °
				-121.392983 °	-121.392983 °
DWR ID	DWR_NA0001_04_s_2012_99				
Comment Code					
FE : Fence					
Inspector Comment					
Wood privacy fence within 10-ft of levee toe obstructs access and visibility.

03/16/2012 Wood privacy fence completely obstructs access and visibility.

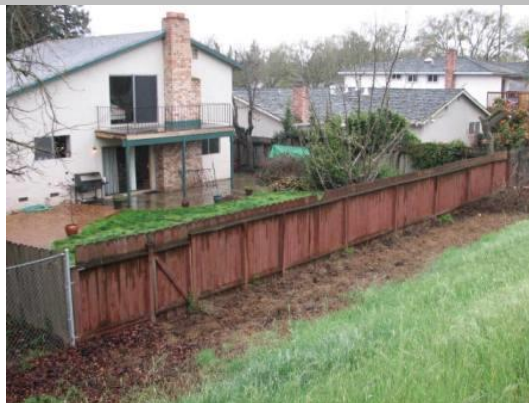
Photo 1 of 1 : SP_2017_NA0001_55_100_20170313_00084.jpg

LM Start	8.27	Rating **	U	Issue No.	100
LM End	8.27	Issue Type +	En	Location *	LS
Category	Earthen Levee			GPS Latitude/Longitude	
				Start	End
Item	Encroachments			38.562182 °	38.562182 °
				-121.392778 °	-121.392778 °
DWR ID	DWR_NA0001_04_s_2012_100				
Comment Code					
FE : Fence					
Inspector Comment					
Wood privacy fence within 10-ft of levee toe obstructs access and visibility.

03/16/2012 Wood privacy fence completely obstructs access and visibility.

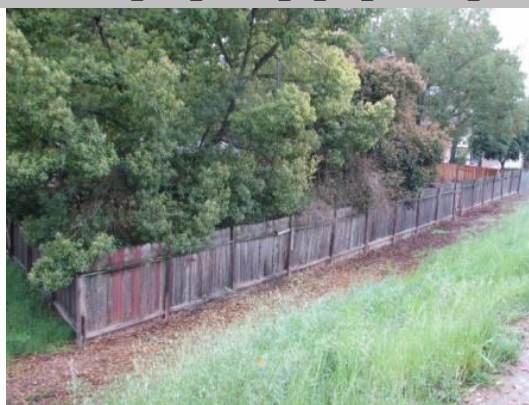
Photo 1 of 1 : SP_2017_NA0001_55_101_20170313_00085.jpg

LM Start	8.32	Rating **	U	Issue No.	101	
LM End	8.32	Issue Type +	En	Location *	LS	
Category	Earthen Levee			GPS Latitude/Longitude		
				Start	End	
Item	Encroachments			38.562508 °	38.562508 °	
				-121.392037 °	-121.392037 °	
DWR ID	DWR_NA0001_04_s_2012_101					
Comment Code						
FE : Fence						
Inspector Comment						
Wood privacy fence within 10-ft of levee toe obstructs access and visibility.

03/16/2012 Wood privacy fence completely obstructs access and visibility.

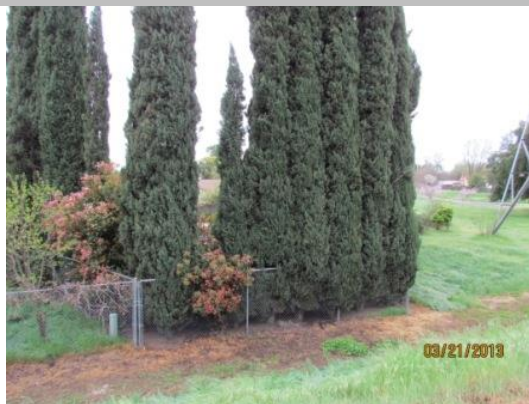
Photo 1 of 1 : SP_2017_NA0001_55_102_20170313_00086.jpg

LM Start	8.38	Rating **	M	Issue No.	102
LM End	8.38	Issue Type +	En	Location *	LS
Category	Earthen Levee			GPS Latitude/Longitude	
				Start	End
Item	Vegetation			38.562889 °	38.562889 °
				-121.391042 °	-121.391042 °
DWR ID	DWR_NA0001_04_s_2012_102				
Comment Code					
V6 : Landscaping					
Inspector Comment					
Helix sky pencil along chain link fence is within 10-ft of the levee toe.

View of the landscaping at the levee toe.

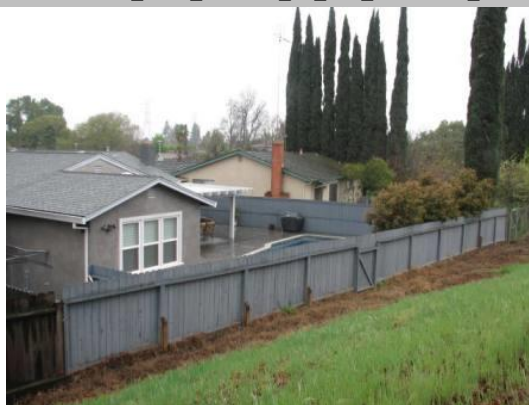
Photo 1 of 1 : SP_2017_NA0001_55_103_20170313_00087.jpg

LM Start	8.40	Rating **	U	Issue No.	103
LM End	8.40	Issue Type +	En	Location *	LS
Category	Earthen Levee			GPS Latitude/Longitude	
				Start	End
Item	Encroachments			38.563042 °	38.563042 °
				-121.390692 °	-121.390692 °
DWR ID	DWR_NA0001_04_s _ 2012_103				
Comment Code					
FE : Fence					
Inspector Comment					
Wood privacy fence within 10-ft of levee toe obstructs access and visibility.

03/16/2012 Wood privacy fence completely obstructs access and visibility.
